Report No. FAA-RD-77-55

IMPROVED RESISTANCE TO
ENGINE BIRD INGESTION

MARCH 1977

FINAL REPORT

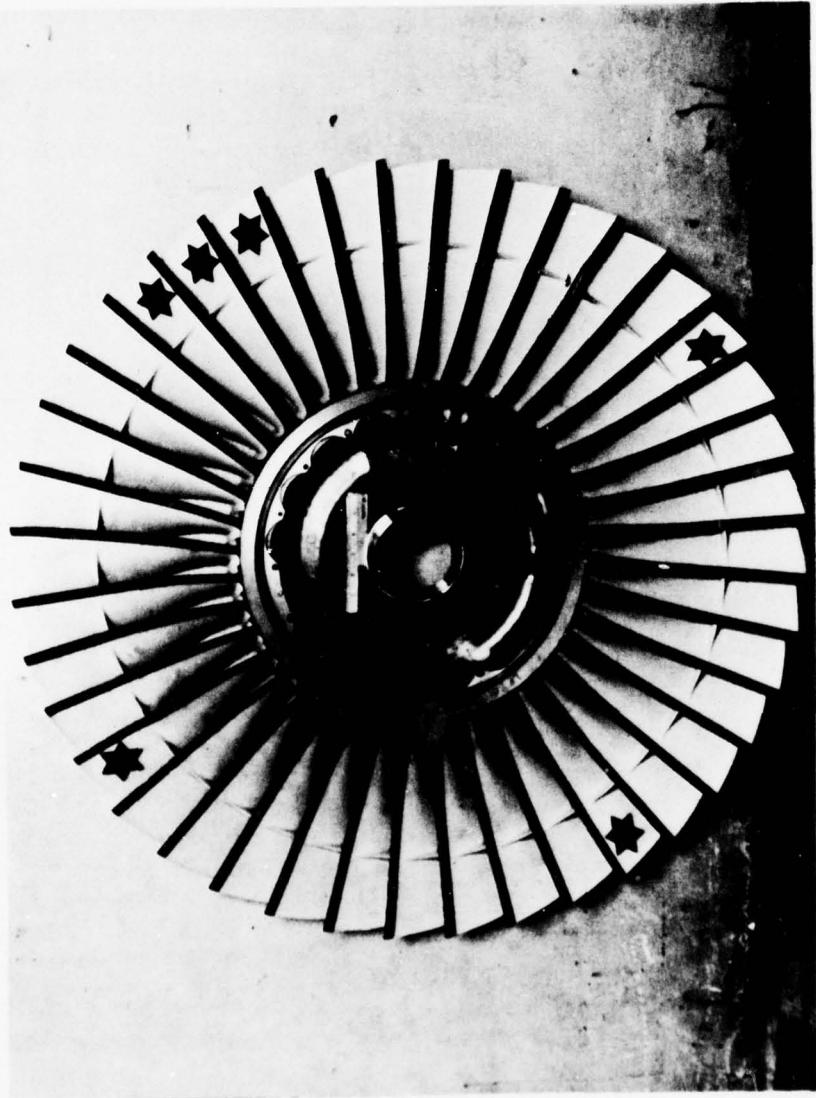
Shroud Strikes of Two 1.5 lb Birds

Figure 86. Fan After Medium-Bird Ingestion Test,
6800 lbf Thrust.
